# Manhole Inspection Summary

Manhole # S29E\_\_049MH

Insp Date: **12/10/07 1:56 PM**

**Location** Address: **701 CHERRY BLOSSOM**

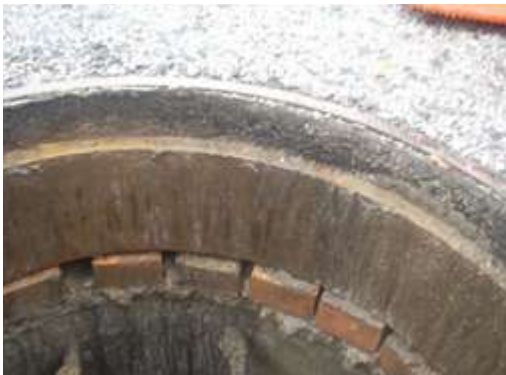
Defect 1

Condition: ☐ Sound ☐ Cracked ☐ Root Intrusion ☒ **Loose Brick** ☐ Deteriorated

LOOSE CHIMNEY BRICKS

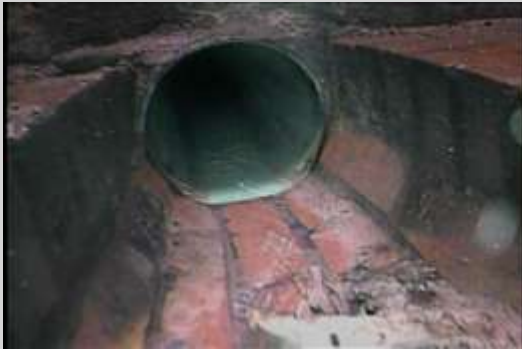
12 O'Clock Outflow

8 in. Circular Gravity Sewer  
Pipe Out @ 12 O'Clock

Pipe Height: **8.4** (in.) Rod and Bar (Angled)  
Pipe Material: **PVC** ☐ Pipe Lined  
Invert Depth: **10.14** (ft.) Flow Characteristics: **Slow**  
Deposits: ☒ None ☐ Mud ☐ Sludge ☐ Debris ☐ Grease  
Silt Depth: (in.) Deposits Extent:  
Infiltration: **None** Pipe Seal Cond: **Sound**

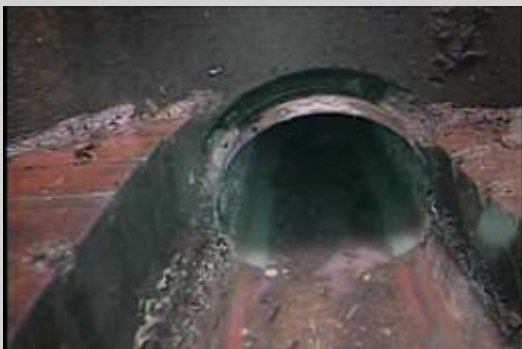
7 O'Clock Inflow

8 in. Circular Gravity Sewer  
Pipe In @ 7 O'Clock

Pipe Height: **7.2** (in.) Rod and Bar (Angled)  
Pipe Material: **PVC** ☐ Pipe Lined  
Invert Depth: **10.02** (ft.) Flow Characteristics: **Slow**  
Deposits: ☒ None ☐ Mud ☐ Sludge ☐ Debris ☐ Grease  
Silt Depth: (in.) Deposits Extent:  
Infiltration: **None** Pipe Seal Cond: **Sound**
